Small UAS Detect and Avoid Requirements Necessary for Limited Beyond Visual Line of Sight (BVLOS) Operations: Final Report

October 25, 2022

1. Report No. A18_A11L.UAS.22		2. Government Accession No.		3. Recipient's Catalog No.	
4. Title and Subtitle Small UAS Detect and Avoid Requirements Necessary for Limited Beyond Visual Line of Sight (BVLOS) Operations: Final Report				5. Report Date October 24, 2022

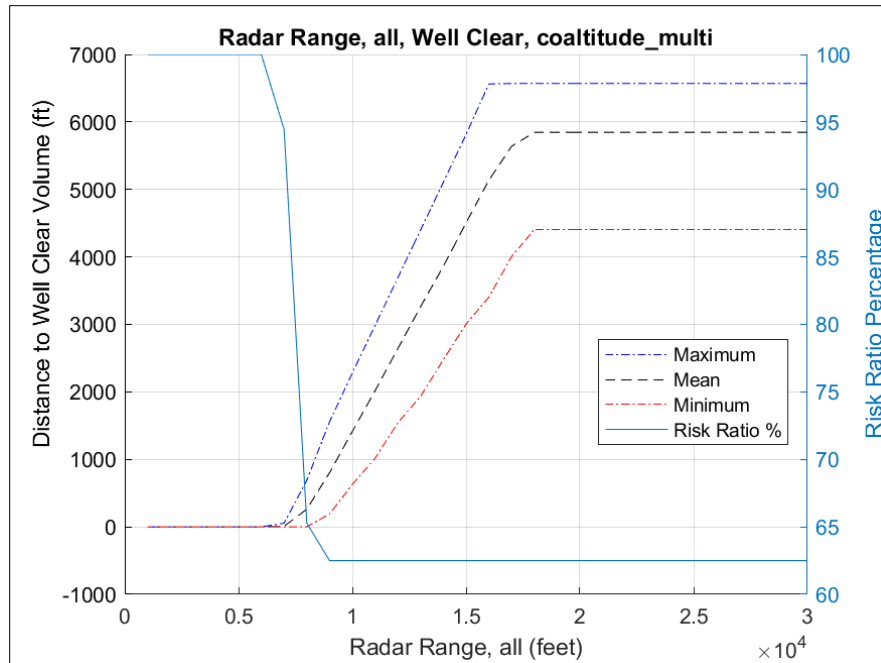
Figure 1. Example separation framework results for a radar-based DAA system [cf. Figure 19 of Kaabouch et al. (2020)]. Lefthand y-axis is distance to well clear volume (minimum, mean, and maximum) for encounters in which well clear was maintained and righthand y-axis is estimated risk ratio. X-axis is radar detection range in 10^4 ft. Results are for co-altitude encounters, an assumed multi-rotor aircraft, and a radar-based DAA system with limited FoV in both the horizontal and vertical directions. For further details, see Kaabouch et al. (2020).

An example of results is provided in Figure 1. As shown in Figure 1, estimated risk ratio drops with increasing detection range, as expected. The lowest value for estimated risk ratio is driven by the limited FoV of the assumed DAA sensor [cf. Kaabouch et al. (2020) for details]. Distances to the well clear volume, for encounters in which well clear is retained, increase and then stabilize with increasing detection range. For the assumed conditions and these simulations, maintenance of well clear starts to be possible for detection ranges in the 7000-8000 ft range.

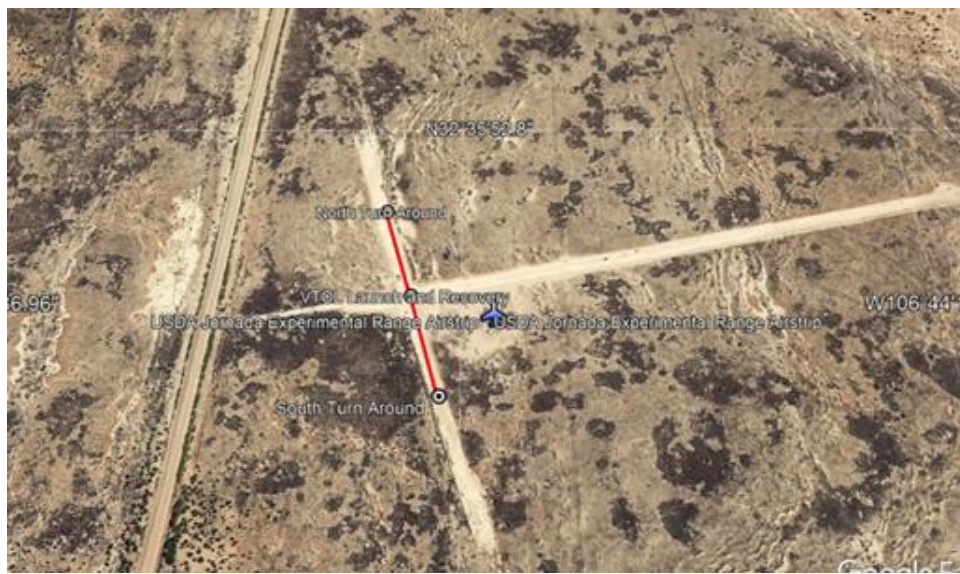
Figure 16. Example multi-copter UAS flight path. The fixed wing UAS path doubles this length and loops at the ends.

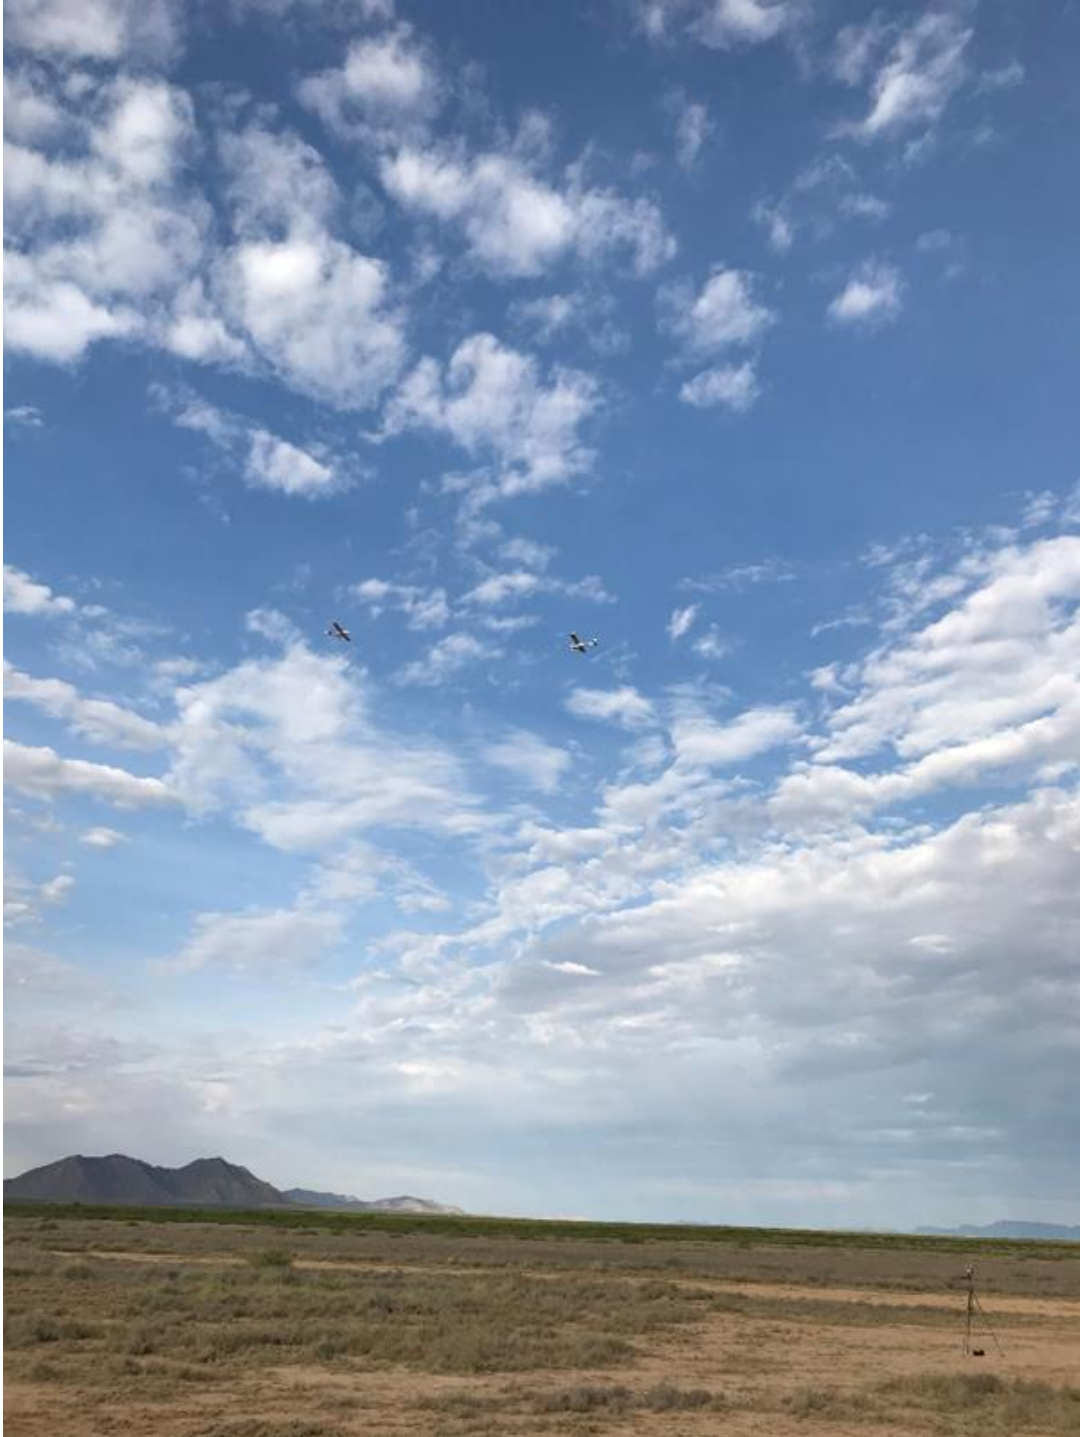
Figure 20. Crossing encounter DAA test.

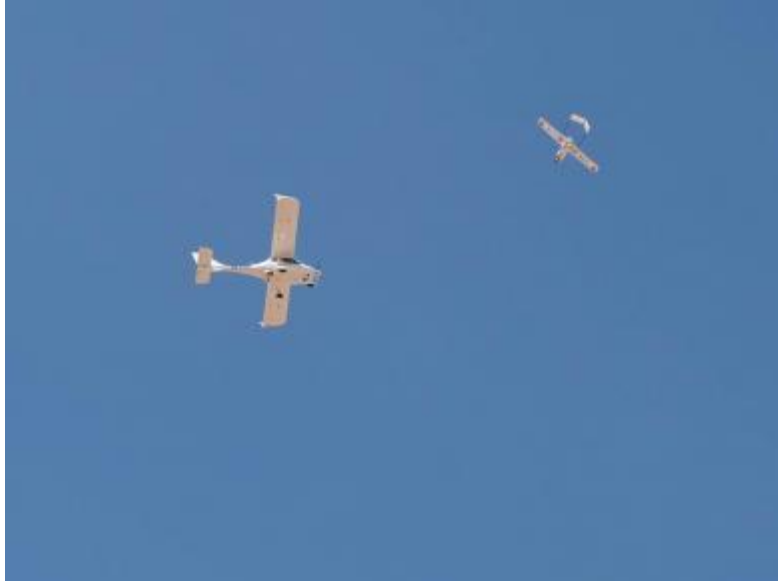
Figure 21. DAA test encounter after turn had been initiated.

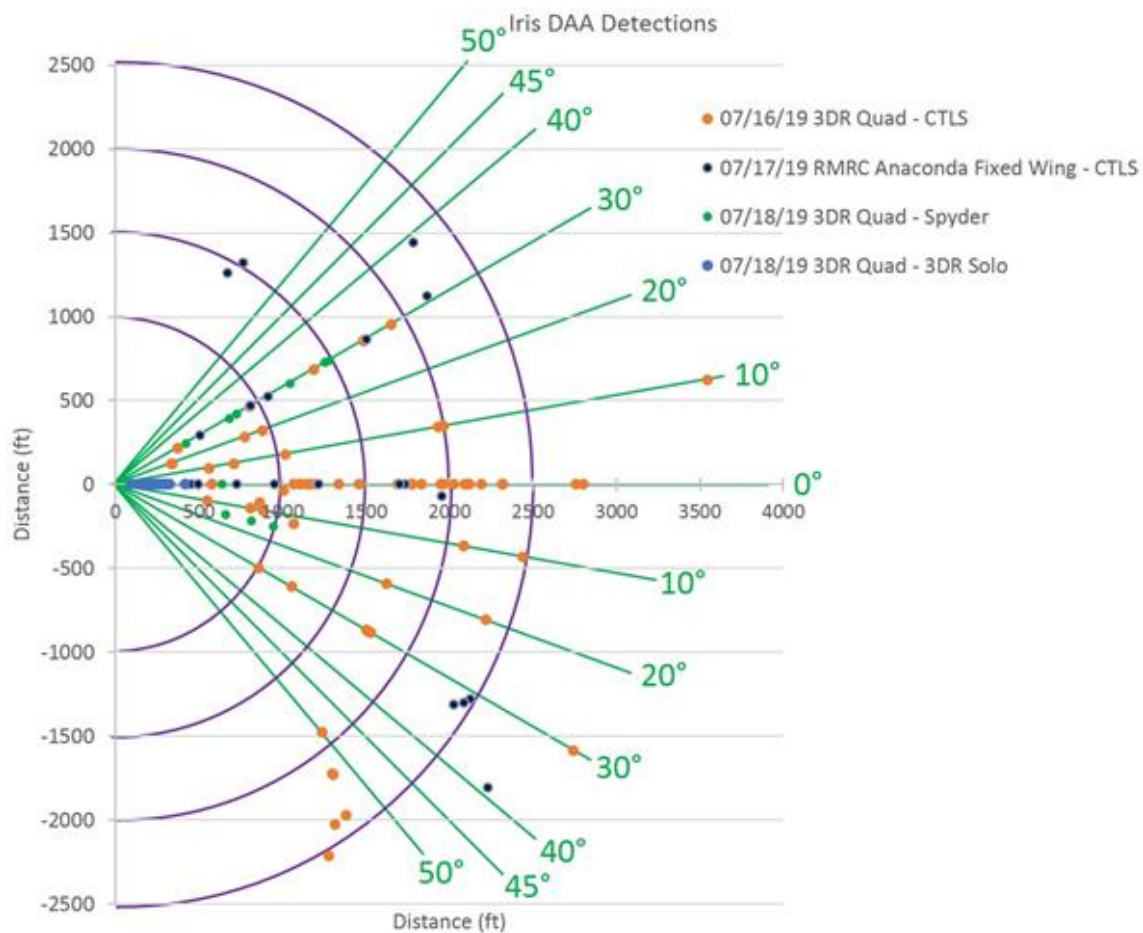
Figure 22. Mapping of Iris DAA detections based on encounter angle and distance.

A mapping of the detections by day is provided in Figure 22. These have all been nominalized to distances and encounter angles as if the DAA system was stationary and represents the origin point. The distances at which the DAA system detected the intruder are shown. An overlay on this shows a function of the encounter angle. Detections along the flight track, represented by the 0° angle, represent most of the detections. The other encounter angles show clear detections mostly along the 10°, 20°, and 30° radials on either side of this center line. A few detections occurred outside these ranges as well. Essentially, Figure 22 is a map of all of the detections shown in summary tables. The crossing patterns, circular detection patterns, and pop-up flights are included but are difficult to identify with this full mapping.

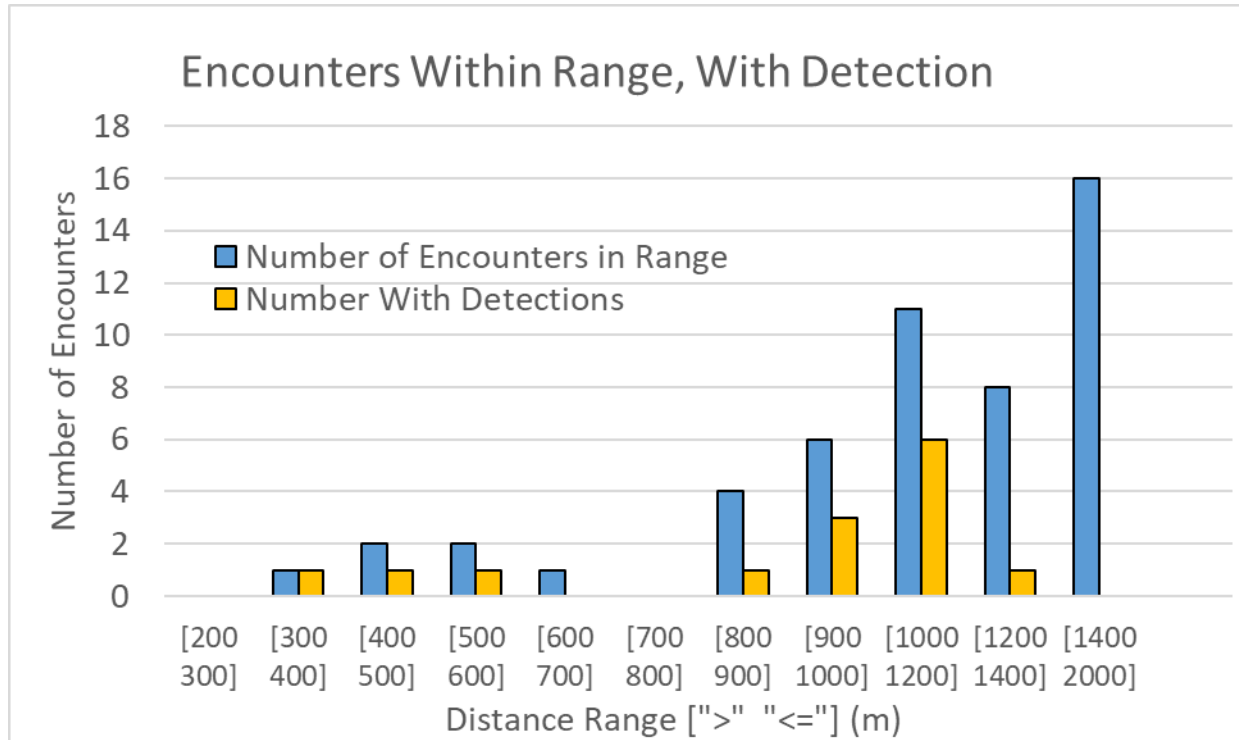
Figure 24. Summary of viable encounters versus detections.

IRIS’s stated detection rate for the tested system was 70% at 390 m when allowed 3 s. This type of encounter is difficult to construct because of the limited FoV of the sensor and the required altitude offset between UAS and intruder trends encounters to distances > 800 m. Despite this, the very limited data acquired does show that IRIS achieved a 67% detection rate for distances < 400 m (Figure 24).

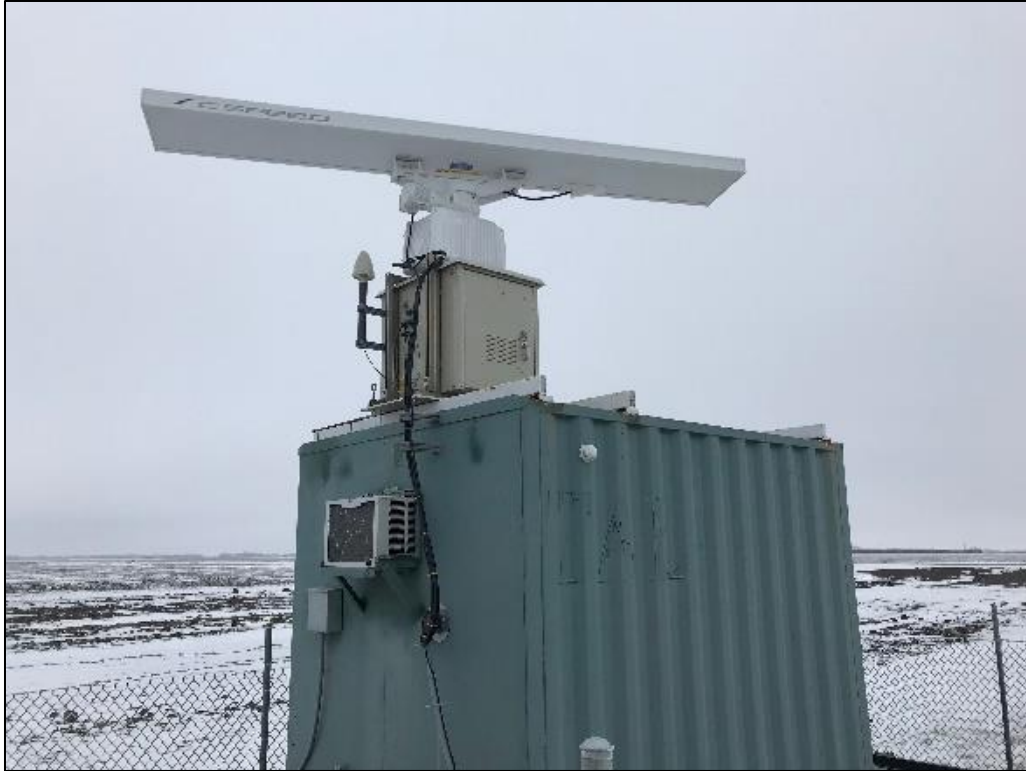
Figure 29. The C Speed Lightwave Radar utilized during the September 2020 UND campaign.

The L3Harris™ Technologies DAA system obtains intruder detection data from several sources. Non-cooperative data are provided using a C Speed Lightwave Radar (C Speed 2022; Figure 29). This is a low-cost, flexible, “software-defined”, S-Band, 2D (two-dimensional) radar technology platform that can serve a broad range of surveillance missions through reconfiguring of its run-time parameters. Cooperative data are obtained from the L3Harris™ Surveillance and Broadcast Services Subsystem (SBSS) Value Added Service (VAS) and from local Xtend™ ADS-B units (L3Harris 2022) that act as gap-fillers to provide surveillance coverage in areas that may not be effectively covered by the FAA’s system (provided through the SBSS VAS).

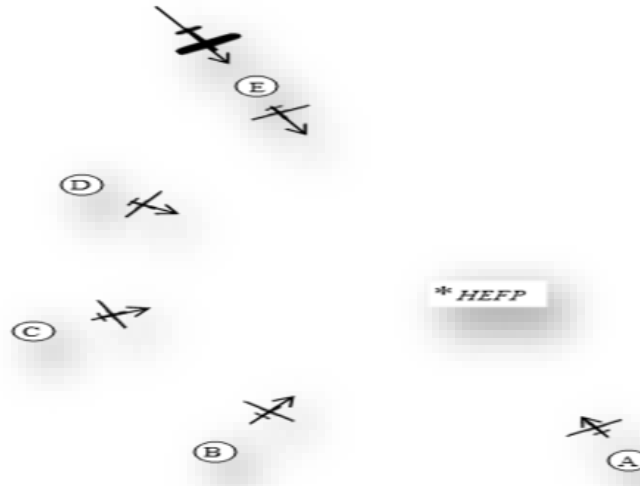
Figure 30. Illustration of encounters associated with the CA flying northwest to southeast. The top image illustrates aircraft paths and origination points. The bottom figure provides labels for UA origination points.

A total of 16 test scenarios/profiles were executed (8 encounter angles x 2 intruder speeds).

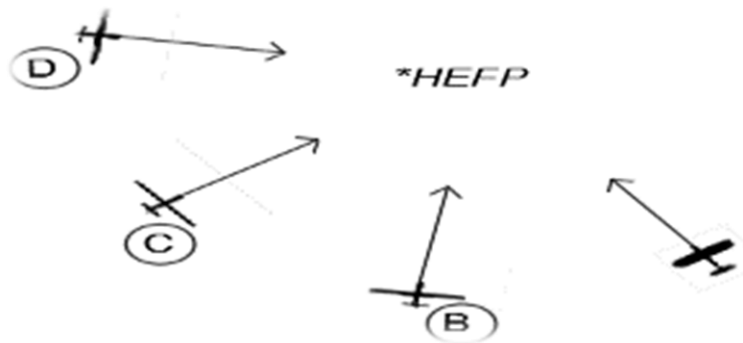
Figure 31. As in Figure 30 but for the CA flying southeast to northwest.

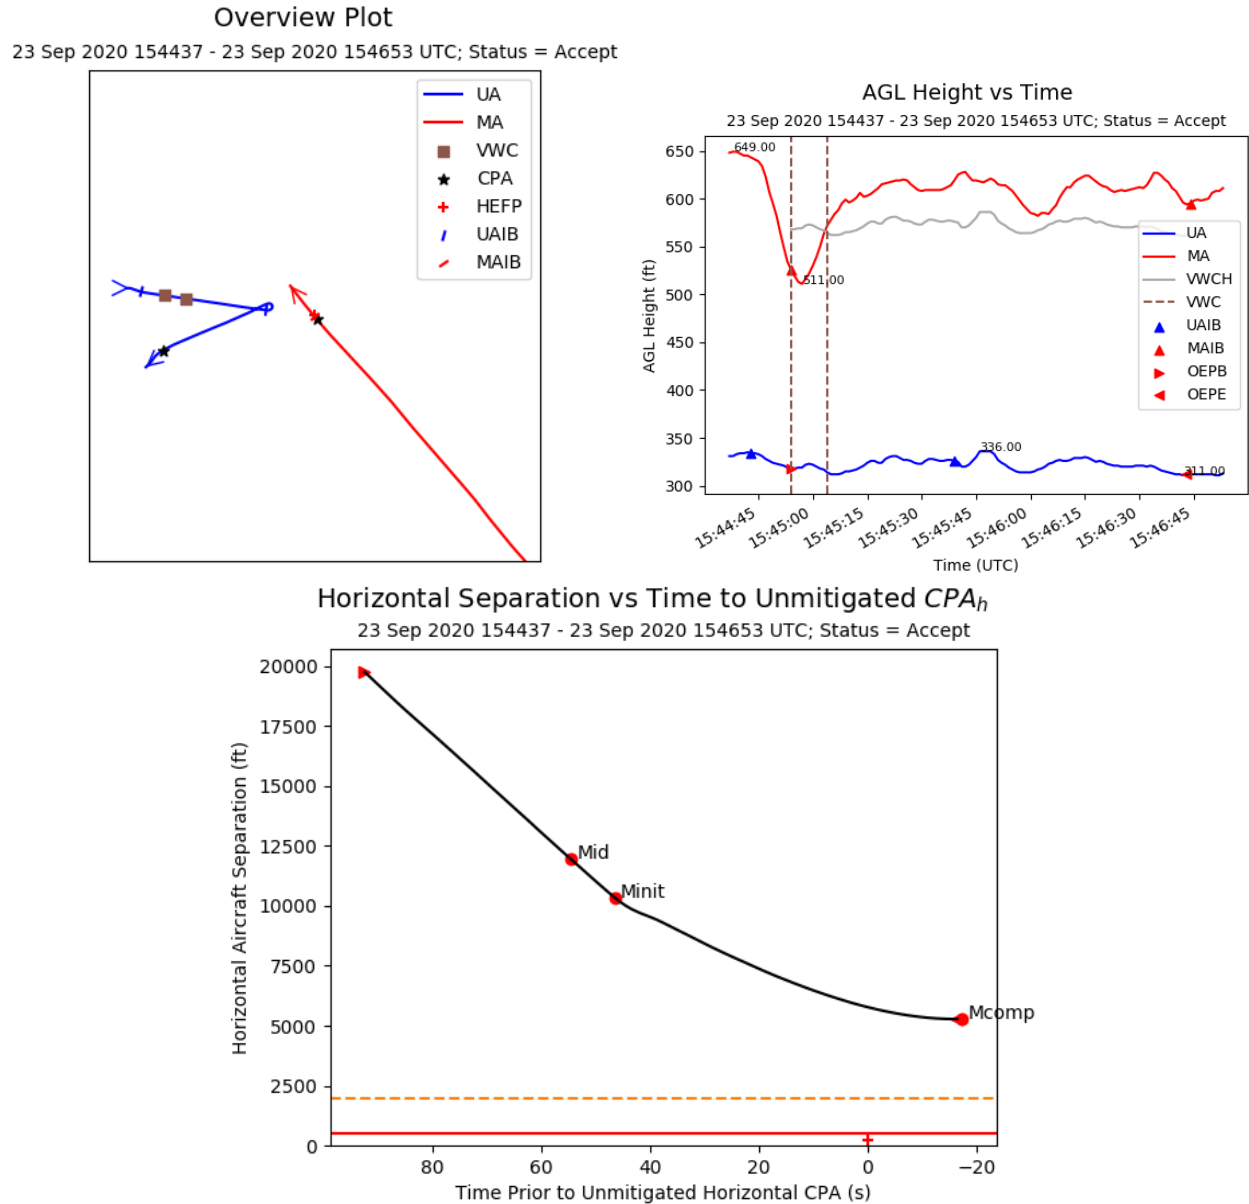
Figure 33. Illustration of the 154437-154653 UTC 23 September 2020 encounter. Upper left provides a plan view, with the UA flight path in blue, CA flight path in red, the period of vertical well clear violation indicated by brown boxes superimposed on the UA flight path (well clear and horizontal well clear are indicated by red and orange boxes, respectively), CPA indicated with a black star symbol, the HEFP indicated with a red plus symbol, and the inbound portions of flight indicated by blue (UA) and red (CA) dashes. Upper right provides a plot of AGL altitudes (relative to HEFP altitude), with the UA altitudes in blue, the CA altitudes in red, the CA altitudes needed to maintain vertical well clear in dark grey, the times of vertical well clear violation indicated by dashed down lines (well clear and horizontal well clear are indicated by dashed red and orange lines, respectively), the UA inbound portion indicated by blue triangles, the CA inbound portion indicated by red triangles, and the Objective Encounter Period [OEP; see Askelson (2022)] beginning and end indicated by rotated red triangles. Bottom is the separation timeline, with the horizontal well clear boundary indicated by the orange dashed line (colored red if a well clear violation occurs), the horizontal NMAC boundary indicated by the solid red line, unmitigated CPA_h (CPA in horizontal direction if UA does not maneuver) indicated by the red plus symbol, the time when both aircraft are inbound indicated with a rotated red triangle (left side of plot), the OEP end indicated with a rotated red

Example results for an encounter executed during this test campaign are provided in Figure 33. Further details regarding encounters, metrics, estimation of uncertainties, etc., are provided by Askelson (2022).

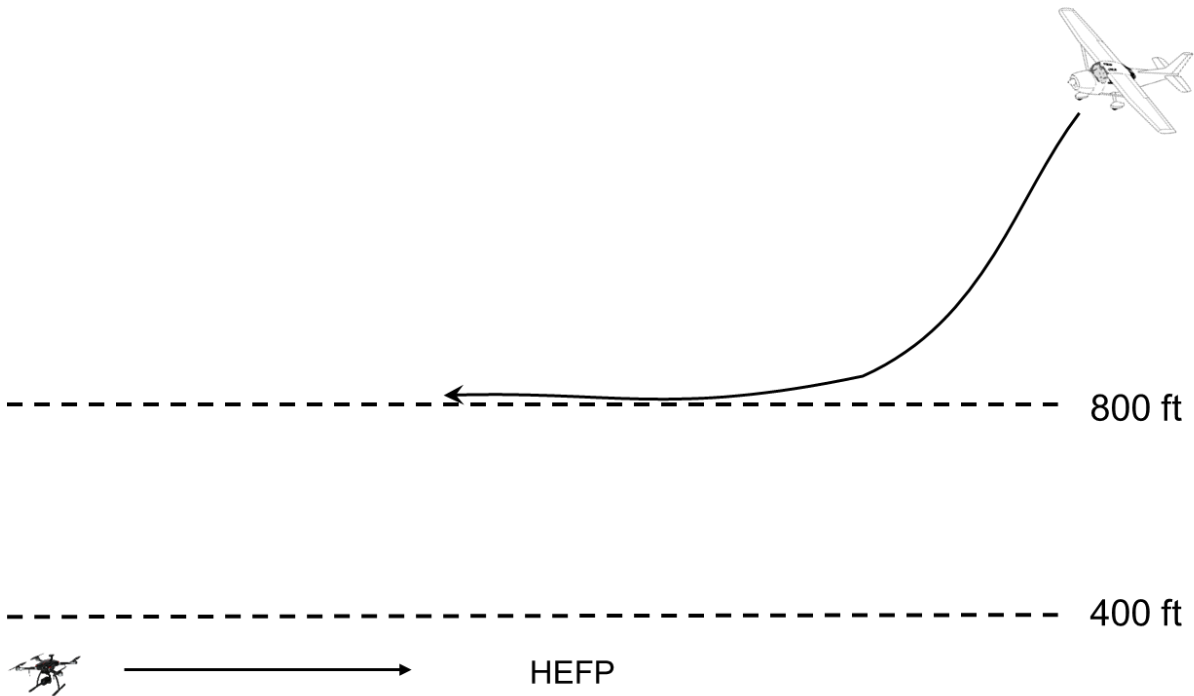
Figure 43. Illustration of descend-into encounters used during the June 2021 UND campaign.

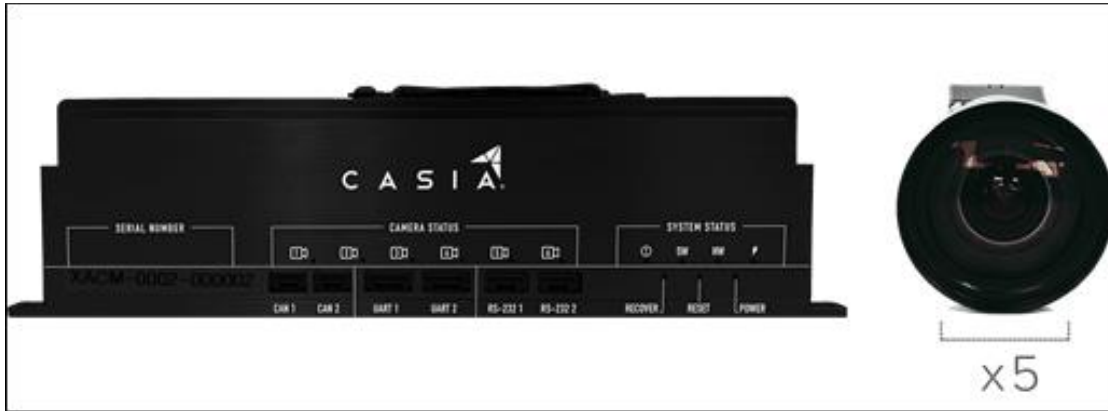
Figure 46. The Iris CasiaX system.

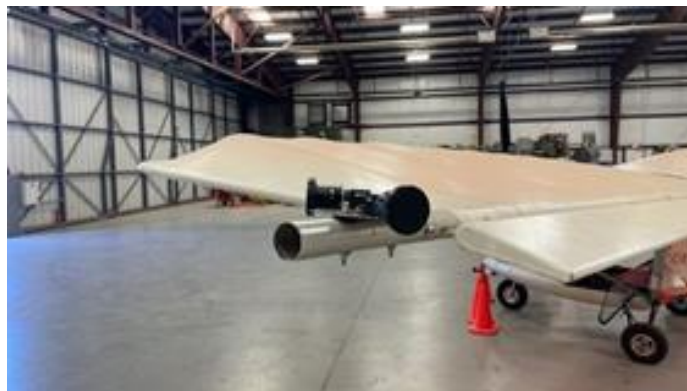
Figure 47. CasiaX cameras mounted on the left wing of ownship.

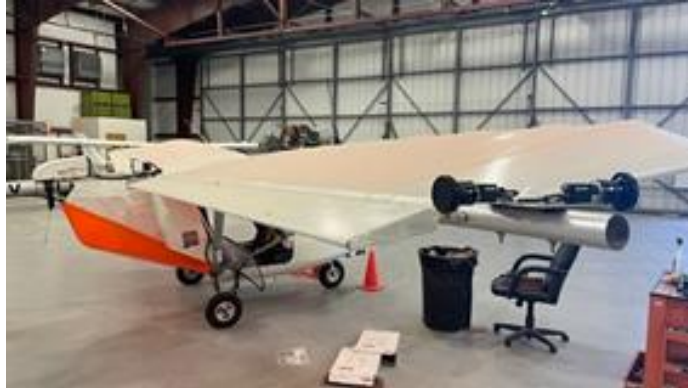
Figure 48. CasiaX cameras mounted on the right wing of ownship.

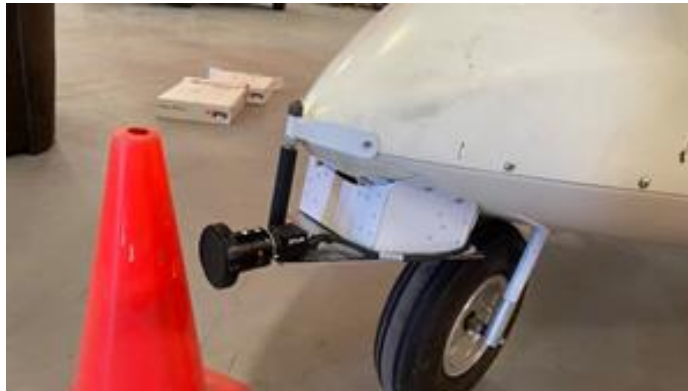
Figure 49. CasiaX camera mounted on the front of ownship.

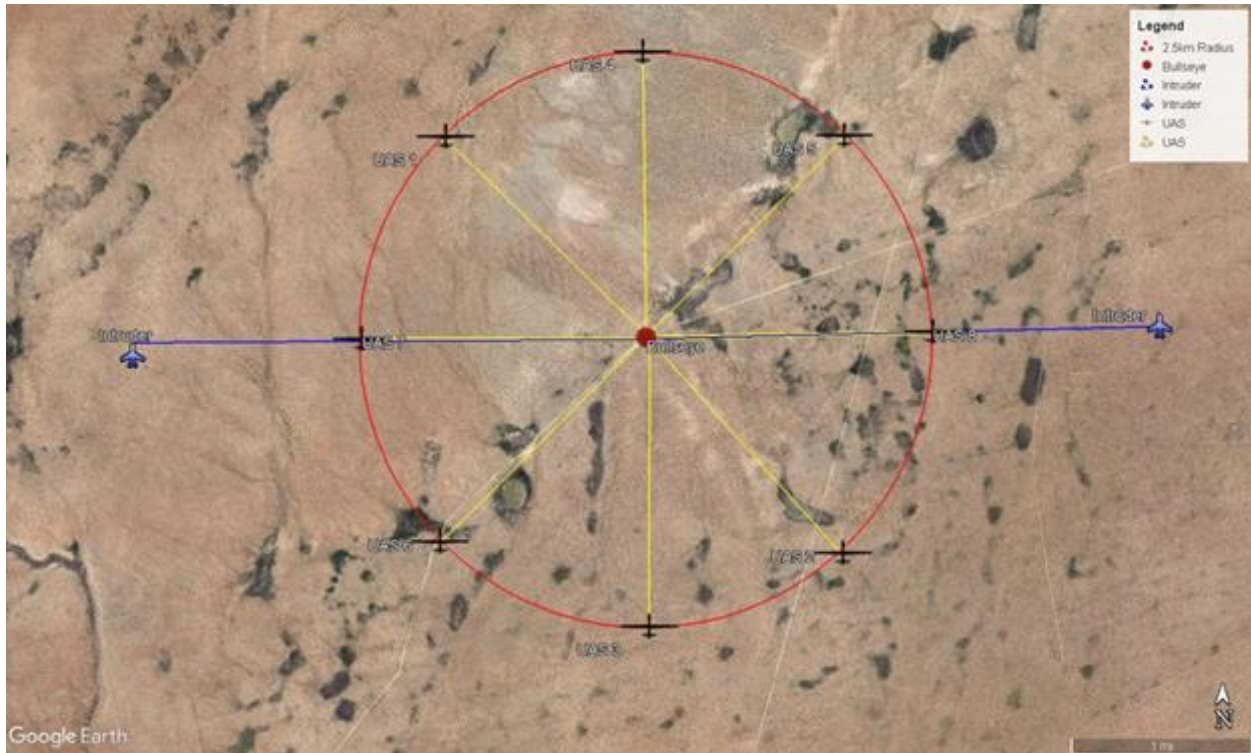
Figure 50. Configuration of horizontal encounters executed during the Fall 2021 NMSU campaign.

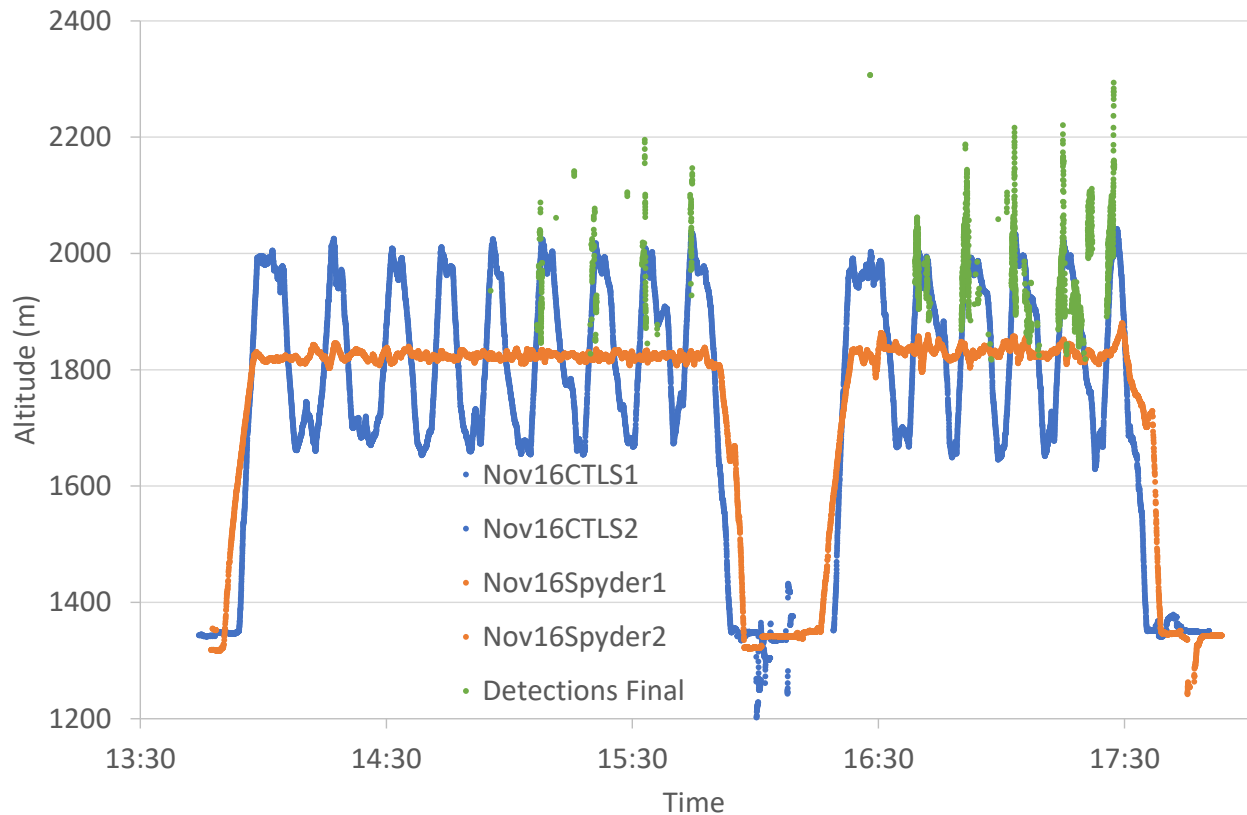
Figure 54. 16 November 2021 flight profiles and detections. Orange dots represent the altitude of the Spyder (with DAA system), blue dots are CTLS intruder altitudes, and green dots are detections.

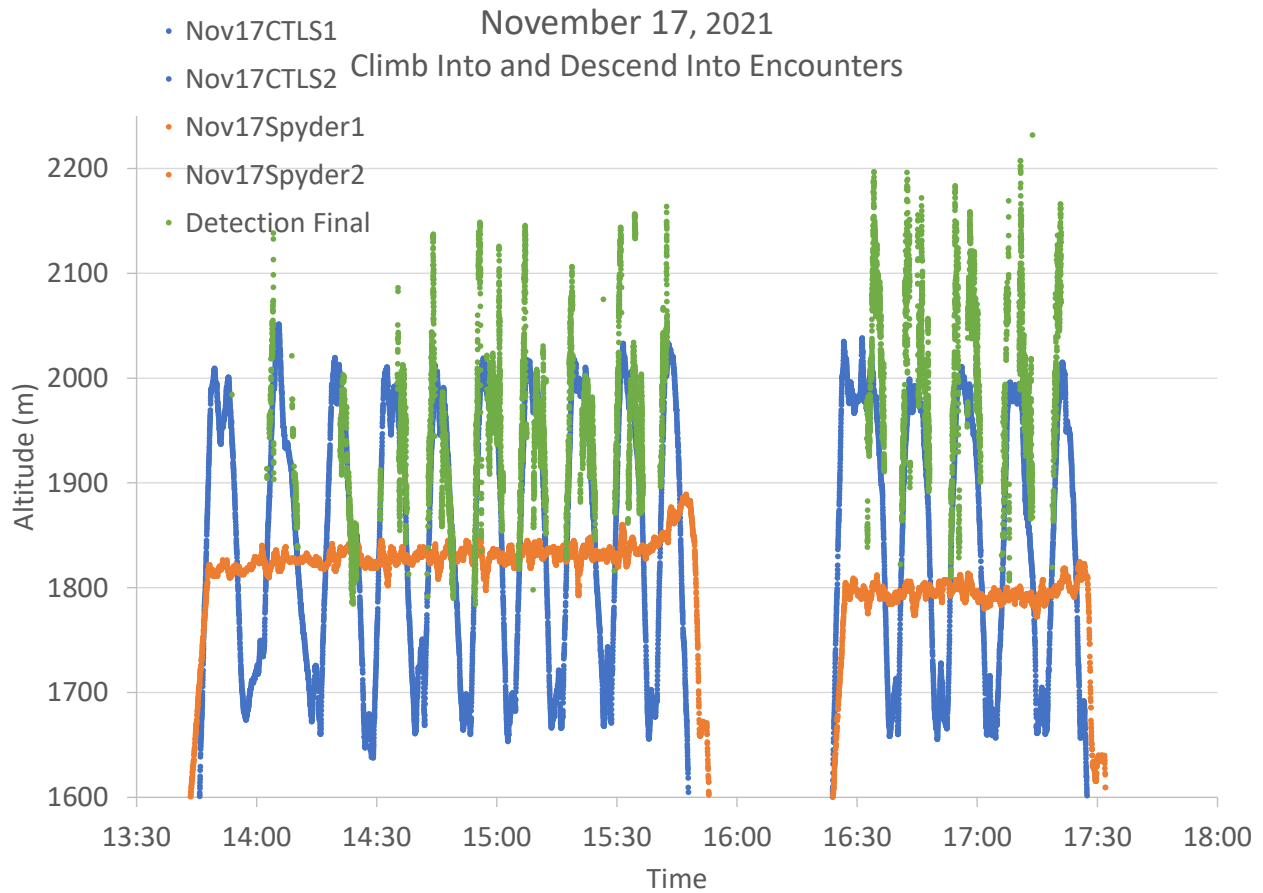
Figure 57. As in Figure 56, but with revised scales.

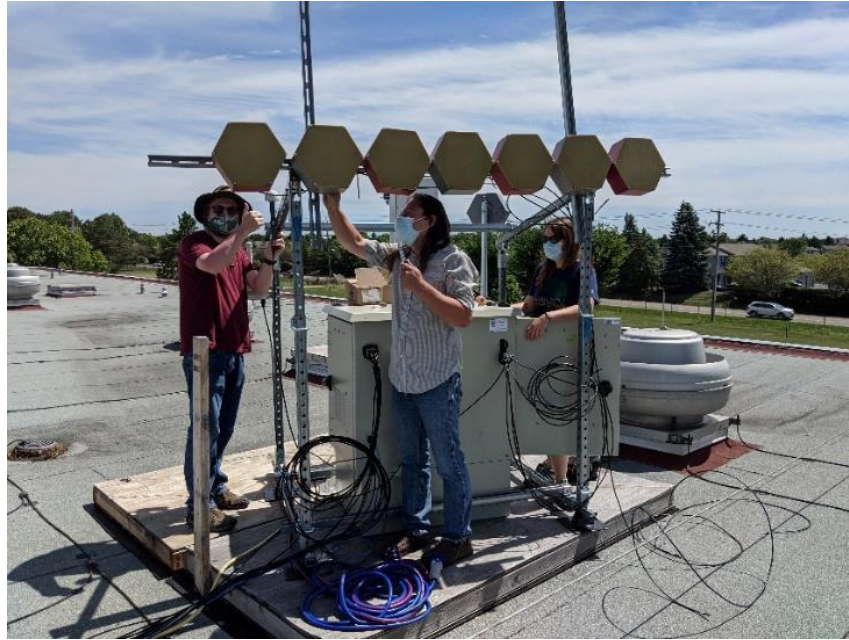
Figure 59. Image of the OSU passive radar system.
